Safety Alert

N°1 1999

Bucket Elevators

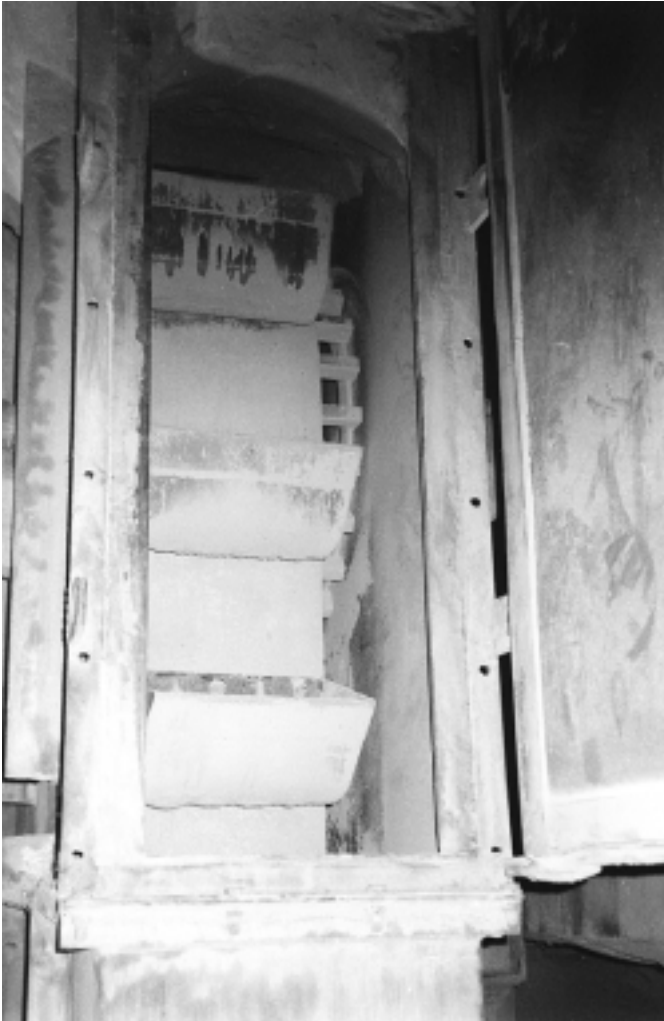
The accident occurred when the fitter pulled the belt to get a better position and the belt, with buckets attached, rolled forward trapping his arm between the belt and the slatted tail drum.

The fitter's arm was severely crushed and lacerated. He could not roll the belt backwards to free his arm because of an anti-roll back device and while attempting to pull his arm free amputated it above the elbow.

- An investigation into this accident revealed that:
- The bucket elevator was not fitted with an anti-runaway device.

- All bucket elevators must be fitted with anti-roll back and anti-runaway devices.
- They must also be 'locked out' electrically while being worked on.
