Safety Alert

N°1 2003

Forest Machine Fire

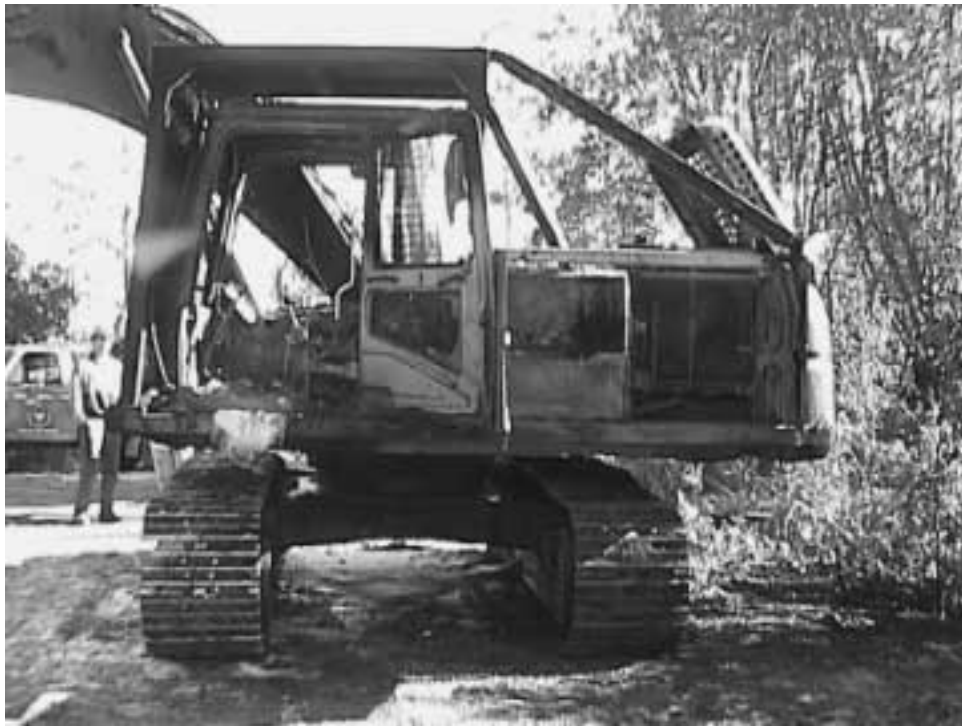
An operator was investigating the source of smoke coming from the underbody of a forestry excavator feller buncher. When he lifted the engine bonnet a fireball occurred, which burned the operator and destroyed the machine.

- small twigs and leaves (fine litter) were able to penetrate hot areas of the machine
- no automatic fire suppression system was installed on the machine.

- That modifications to the machine, in consultation with the manufacturer, be considered to restrict fine litter entering hot areas.
- That operators undertake daily checks of machinery and remove any combustible material from hot areas.
- That maintenance programs include a detailed search for, and removal of, accumulated combustible material and, if warranted, include a thorough wash down of the machine.
- That approved automatic fire suppression systems be fitted to machines working in this environment.
- That operators be trained in machine fire fighting techniques.
- That when the source of a machinery fire is not known, extreme care be exercised in determining its location.
- That appropriate portable fire extinguishers, capable of combating electrical and other fires that may occur on the machinery, be installed.
