Silo collapses from stressed structural weld

Details of incident

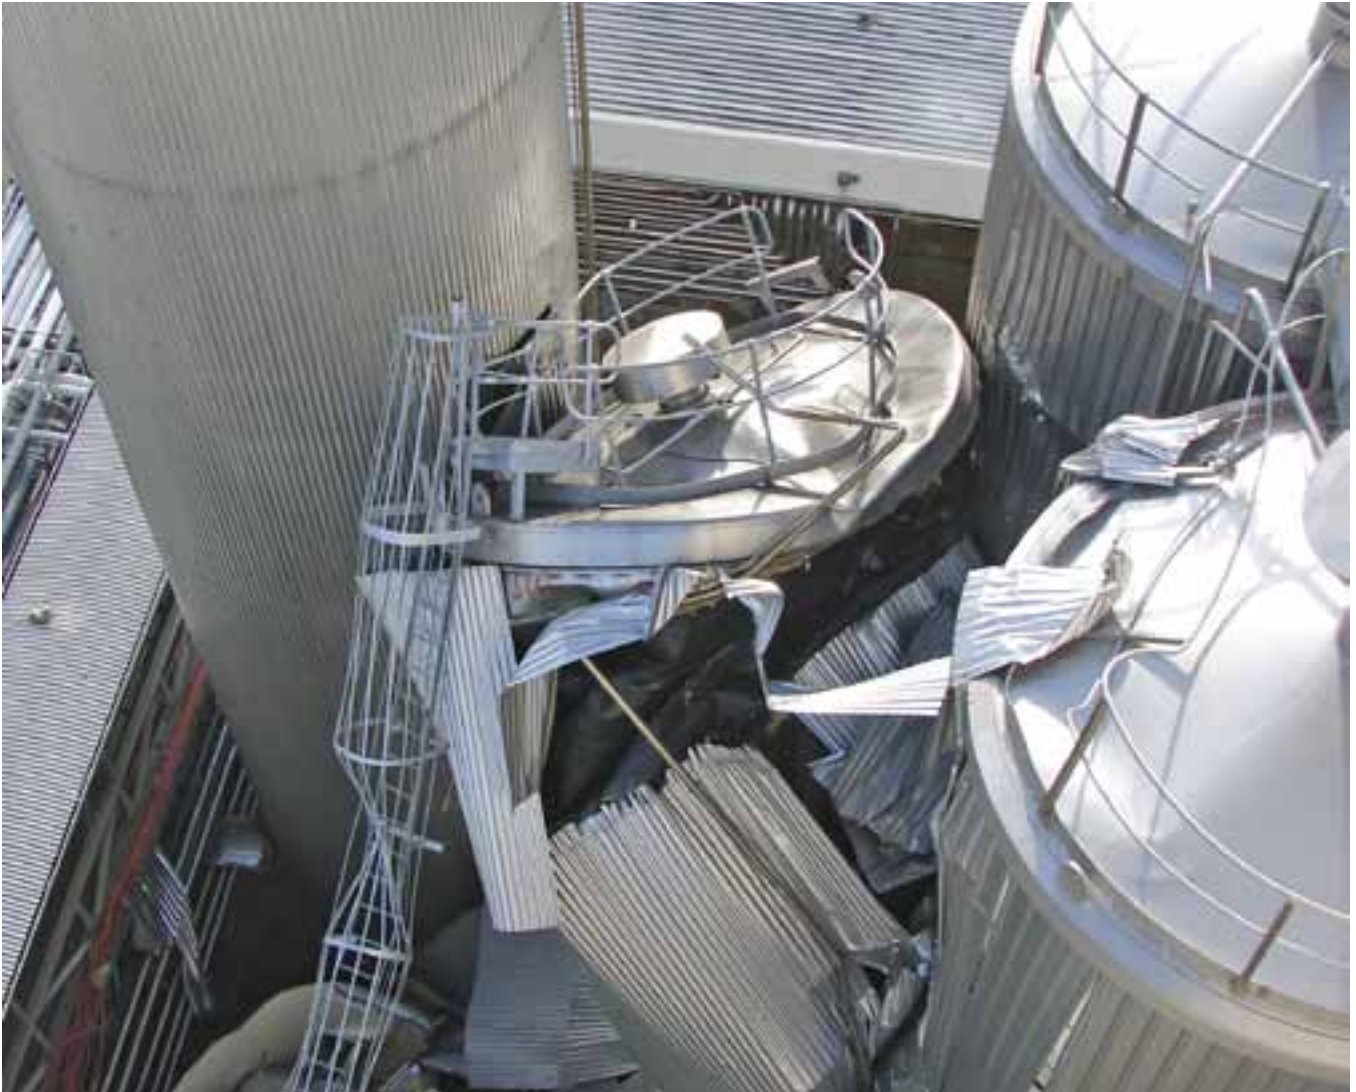
A silo containing 300,000 litres of milk collapsed at a dairy co-op factory recently.

The collapse occurred after the dome bottom tore away, causing a large hole in the silo. The contents then rapidly discharged, creating a negative pressure which sucked in the upper 'barrel' and subsequently collapsed the silo.

- the structural weld between the bottom dome and supporting skirt was highly stressed and had developed cracks over time from constant filling, emptying and cleaning cycles (the silos were manufactured and installed in January 1997)
- the design and execution of the welds between the supporting skirt and the dome bottom of the silo were inadequate.

- Conduct regular inspections of the structural welds.
- Consult engineers on any repairs.
- Check that vents and pressure alarms are adequate and working.
