Safety Alert

N°1 2002

Chrome Plated Fire Hydrant Valve Failure

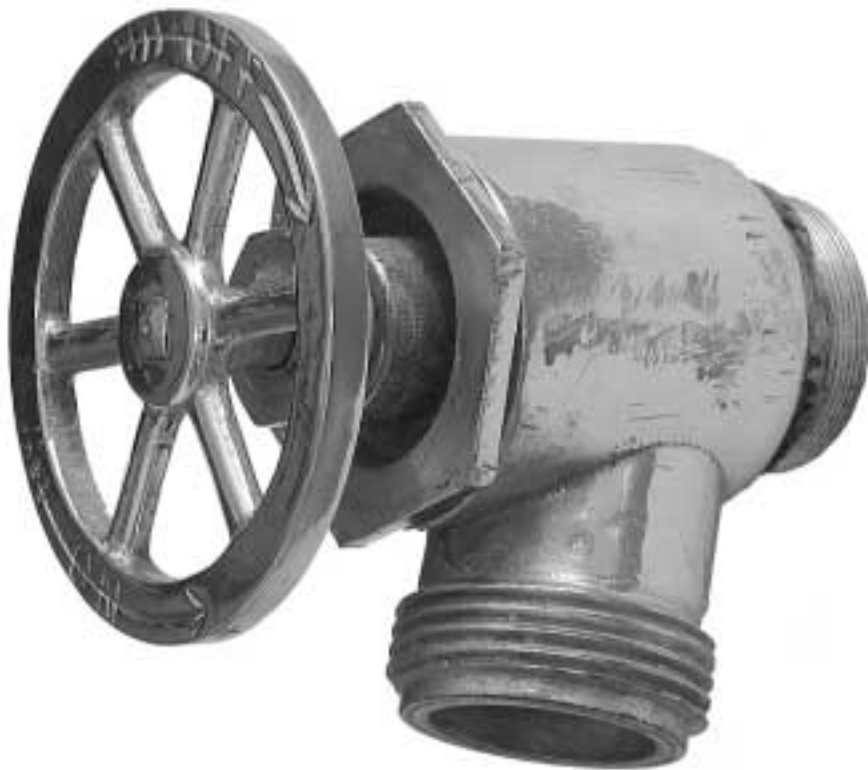
A service technician was injured while applying hand pressure to close a fire hydrant valve to prevent it leaking.

The injury occurred when the centre of the 64 mm chrome plated brass fire hydrant valve, weighing 2.8 kg, was forced from the valve body by the water pressure in the system.

- Washers in this and other fire hydrant valves were replaced two days earlier and were correctly re-assembled.
- The failed valve body appeared to be soft and distorted easily.
- The valve was approx 40 to 50 years old.
- The technician was standing in front of the valve to close it.

Where **chrome plated fire hydrant valves** are installed it is strongly recommended that building owners have them inspected by a 'competent person'. They should be replaced where faulty.

Persons should not stand in front of hydrant valves during servicing, adjustment or operation.
