Safety Alert

N°4 2001

## Violent Splattering of Molten Metal

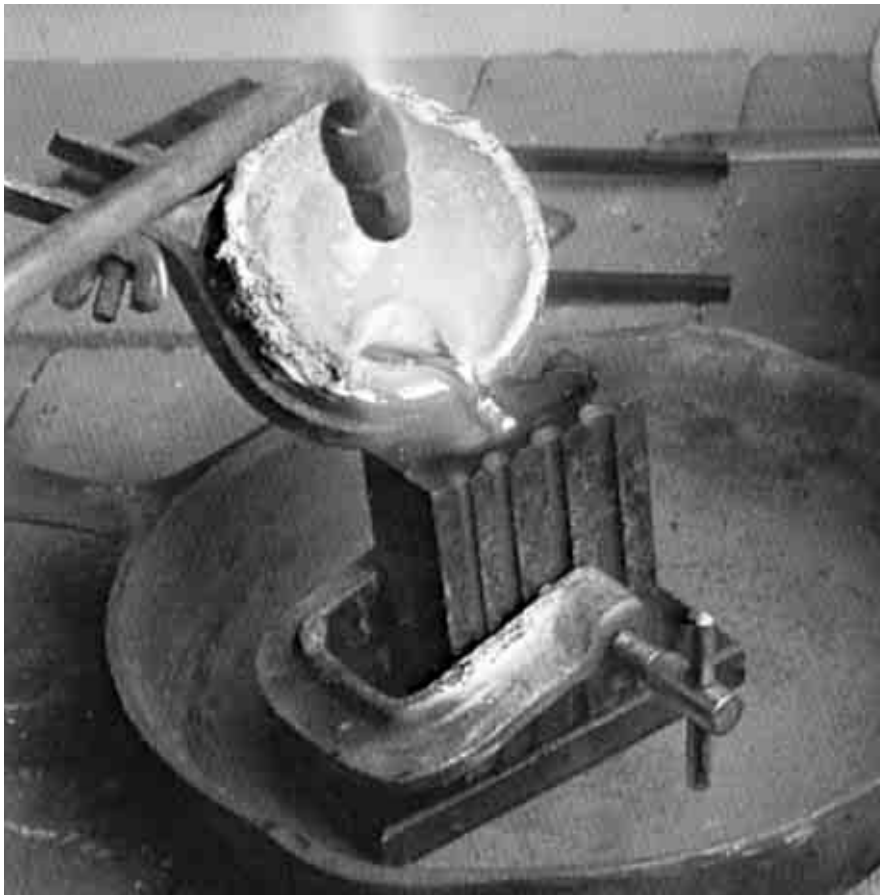
A jeweller was in the process of melting-down 'old gold' items into an ingot. This process involves pouring molten metal from a crucible into a mould. During this task the gold splattered and some molten metal lodged in one of the jeweller's eyes.

The jeweller is expected to lose some vision in that eye.

- The mould had been cleaned with a small scraper and dry cloth, however it had not been preheated to remove residual moisture.
- Protective eyewear was available at the time of the accident but was not worn.

- Moulds should be pre-heated.
- Protective equipment (safety shield, leather gloves and apron) should be worn during all melting/heating processes.
