Number 3 2004

Isolating Rotary Dairy Machinery

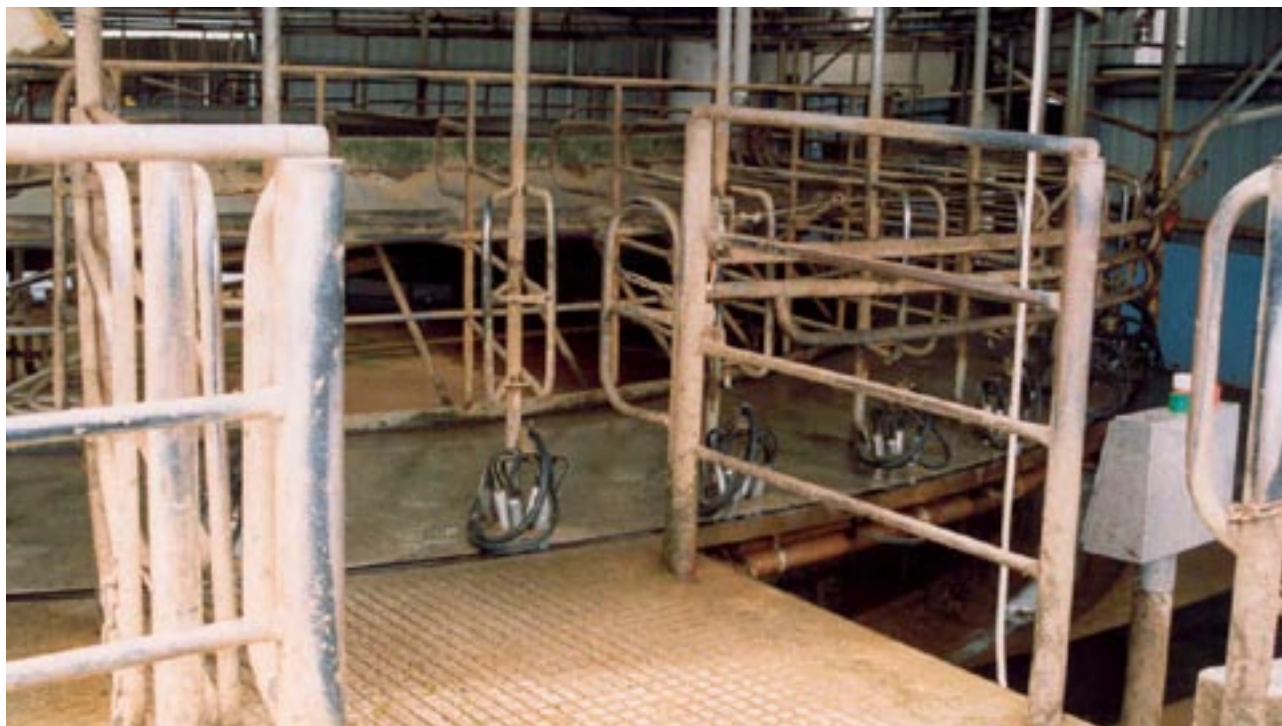
A dairy worker was attempting to get a fully-loaded rotary milking platform moving. It had stopped revolving because of a problem with the drive mechanism.

The worker, believing the drive mechanism was electrically isolated, began to make repairs. However, the platform unexpectedly began moving — which resulted in the machinery amputating one of the worker's fingers.

- the worker had pulled the platform perimeter lanyard and opened the cow safety gate. He knew the lanyard had a reset function and assumed it would isolate the drive mechanism
- however, the cow safety gate did not have this feature. Therefore, when the worker pulled the platform perimeter lanyard and opened the cow safety gate, only the circuit on the cow safety gate was opened. The lanyard did not open the drive circuit
- cows can become restless when confined in a rotary stall if there is no movement. In this particular incident, a restless cow actually moved the gate. This closed the circuit and restarted the drive mechanism.

- Power must be correctly isolated before gaining access to any machinery.
- Full isolation must be achieved by opening all circuits, which must be locked off and tagged out.
- All workers must be trained in the isolation procedures, and fully understand them.
