Mobile crane ground stability

Details

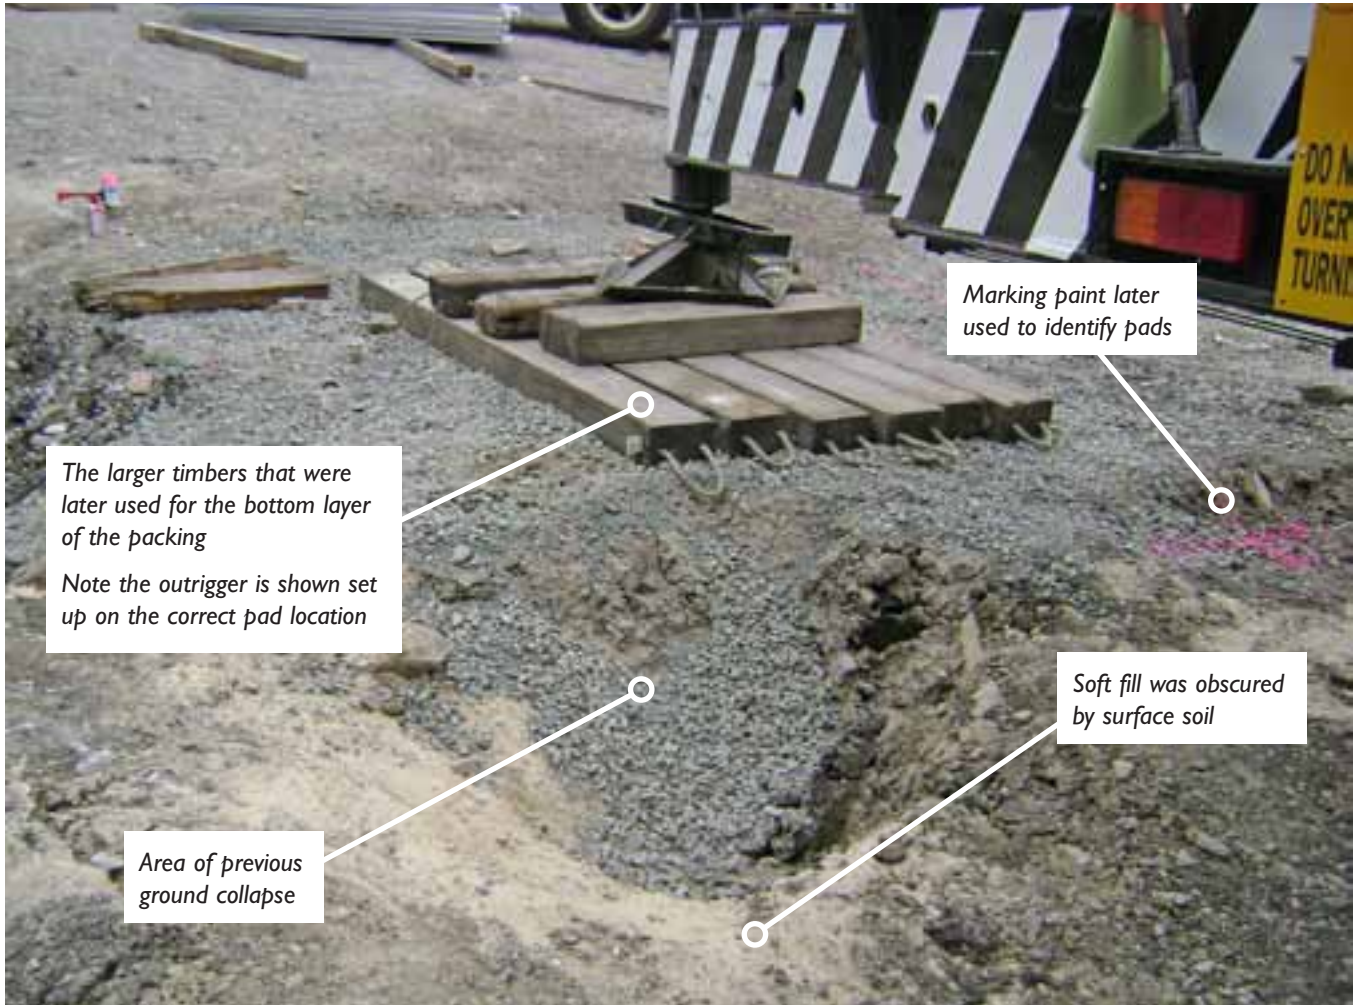
On 9 November 2009 a serious near miss involving a 100 tonne mobile crane occurred on a busy construction site. There was potential for multiple fatalities. The crane was being used to lift and position precast concrete panels. The ground beneath one of the crane outriggers collapsed while the crane was lifting a 4 ton panel. The loss of ground stability resulted in the crane outrigger sinking approximately half a metre. Fortunately, the quick placement of extra timbers under the outrigger arm prevented further ground collapse and the panel was able to be lowered without further incident.

- **Identification of outrigger pads:** The installed pads were not easily identifiable and were obscured by surface dirt and loose gravel. As per the photograph, they were later identified with ground marking paint

- **Inadequate outrigger support timbers:** The timbers used by the crane set up crew under the outriggers were inadequate in spreading the load. Subsequently larger timbers were used as shown in the photograph

- a risk assessment must be conducted prior to the use of any mobile crane which includes a formal assessment of the ground stability. Importantly a new risk assessment must coincide with any change in the plant (crane)

- from the risk assessment process, a competent person must ensure that the loads imposed by the crane can be sustained by the ground or any other means of support. AS2550.1—2002 *Cranes, hoists and winches — Safe use — General requirements*, Section 4.2 deals specifically with this requirement

- operators of mobile cranes must be trained and aware of the requirement to ensure that ground stability has been deemed to be satisfactory prior to commencing to set up the crane

- the set up area and any installed or prepared pads must be clearly marked and identifiable
- clear communication channels between all parties engaged to erect precast concrete panels is paramount. When using cranes to lift precast concrete panels, a detailed erection procedure and checklist that conforms or surpasses AS3850—2003 *Tilt up concrete construction* must be in place. A free checklist is available from the Work Safe Victoria Website. Go to www.worksafe.vic.gov.au and search for “checklist for onsite erection of concrete panels”.
