Safety Alert

Nº.7 1999

Concrete Pump Overturns - Worker Breaks Ankle

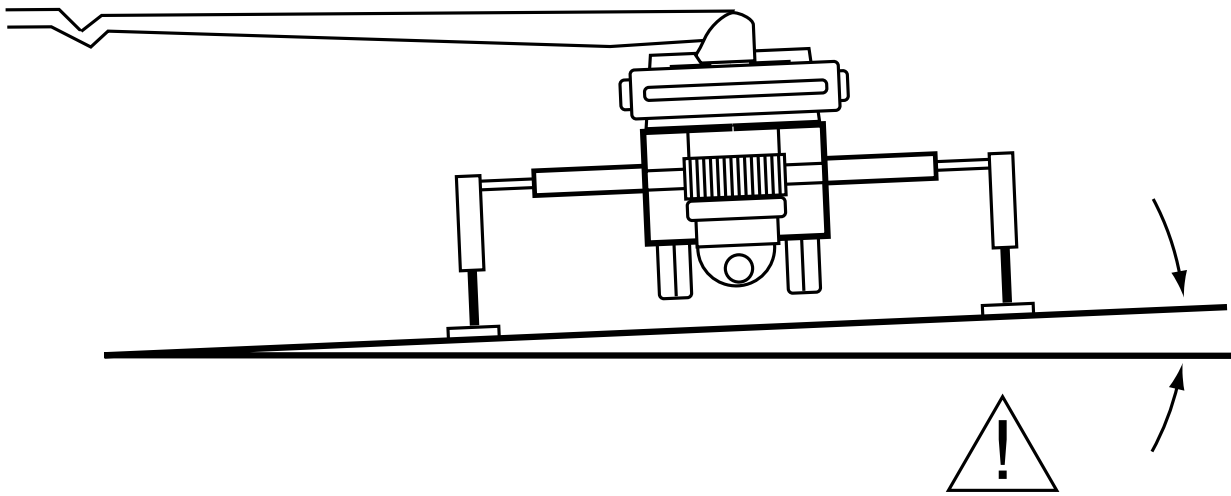
A truck-mounted concrete pump was set up on a sloping (approximately 15o) work site. Timber packing was placed under the outriggers to level the unit. The timber packing under one of the outriggers moved after a short period of pumping and this, coupled with the fact that the pump boom was fully extended, caused the unit to overturn. A worker was hit by the pump boom and his ankle was broken.

- The gradient of the work site was too great for the truck-mounted concrete pump.
- The vibration of the unit caused the timber packing to move from underneath an outrigger.

When setting-up a concrete pump, the ground should be level, well compacted and free of obstructions.

- Ensure the pump is not positioned over or adjacent to:
 - (i) previously disturbed ground that has been back-filled,
 - (ii) excavations, trenches or holes in the ground,
 - (iii) cellars, basements or pits, or
 - (iv) inadequately compacted or soft ground.

- Make sure the pump unit is set up level but if this cannot be achieved ensure:
 - (i) the incline or angle of the machine does not exceed the manufacturer's recommendations (refer to operating instruction manual),

- (ii) adequate timber is supplied for the purpose of packing the outriggers' base plates. The timber should be pigstayed and capable of supporting the machine, and

- (iii) the outrigger pads are clear of excavations, soft or filled ground, or other obstacles that could interfere with the safe operation of the machine. If the ground is not firm, the operator should make sure that the bearing pressure of the ground is not exceeded by the bearing pressure exerted by any outrigger.

- Particular care should be taken when a concrete pump is used in the vicinity of an excavation. The weight of the concrete pump and the load can impact on the stability of the excavation wall and cause a slip which could lead to the concrete pump overturning.
