Number 1 2004

Tipping Over of Mobile Cranes

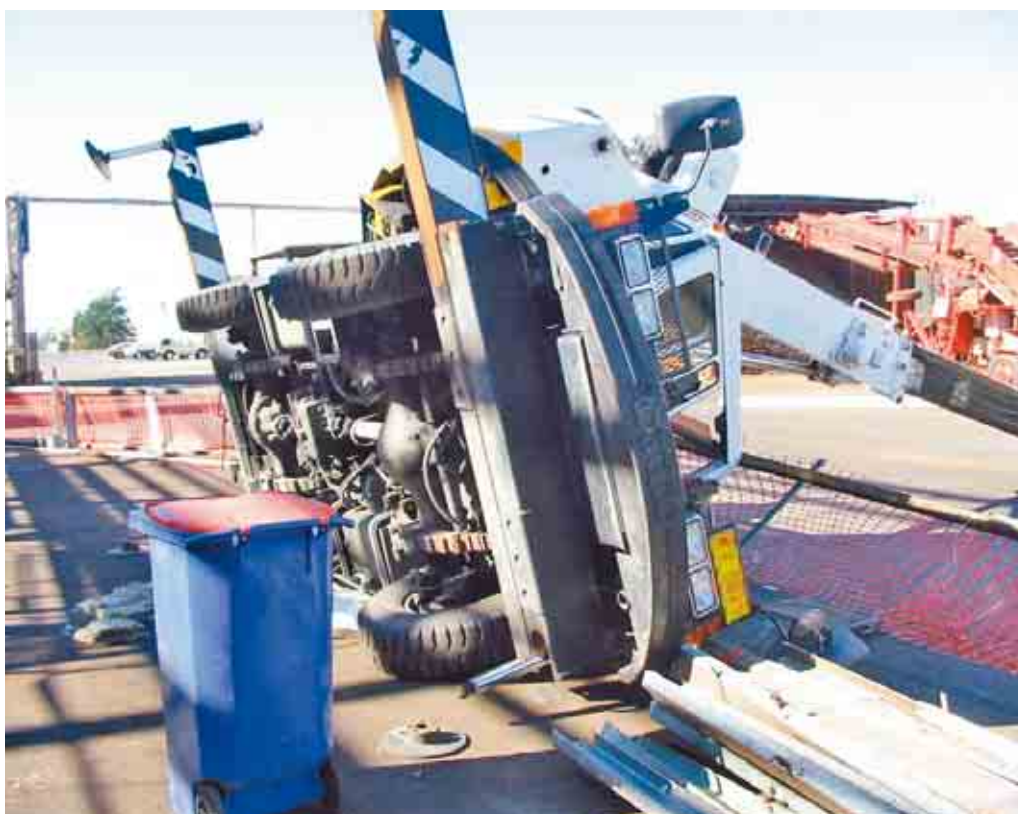
Last year two mobile slewing cranes tipped over in separate incidents in the north of the state. This was despite the weight of the loads being within the safe working capability of the cranes. In both cases the damage caused to the cranes was extensive, leaving both cranes unserviceable. Fortunately no one was injured as a result of these incidents.

- An adequate risk assessment addressing the particular hazards associated with the task had not been carried out before the start of work.
- The operators held certificates of competency but were part-time crane drivers.
- In the first crane incident, the outrigger legs were extended on one side of the crane only. In the second crane incident, the outrigger legs were not extended at all. This significantly reduced the safe working capacity of the cranes. Had the outrigger legs been fully extended, neither crane would have tipped over.
- One operator had knowingly entered incorrect information into the 'moment limiting device' fitted to his crane. This rendered it ineffective in warning the operator of a pending tip-over. The second machine did not have any moment limiting or warning devices fitted.

- Install moment limiting or load indicating devices to the crane. These provide valuable information and signals to the operator. While these are not a substitute for good judgement and experience, they can significantly reduce the risk of tip-over or structural failure provided the correct information is entered into the device. These devices provide extra margins of safety, which is especially relevant with part-time operators.
- Always operate the crane in accordance with the manufacturer's information contained in the operator's manuals.
- Set up the crane with the outrigger legs fully extended at all times to maximise the safe working capacity of the machine.
- Provide training for operators on the risk assessment process, and ensure a risk assessment is carried out before setting up the crane.
