## Electricity Industry Bulletin No: 64 March 2007

### FOR THE ATTENTION OF ALL ELECTRICAL WORKERS

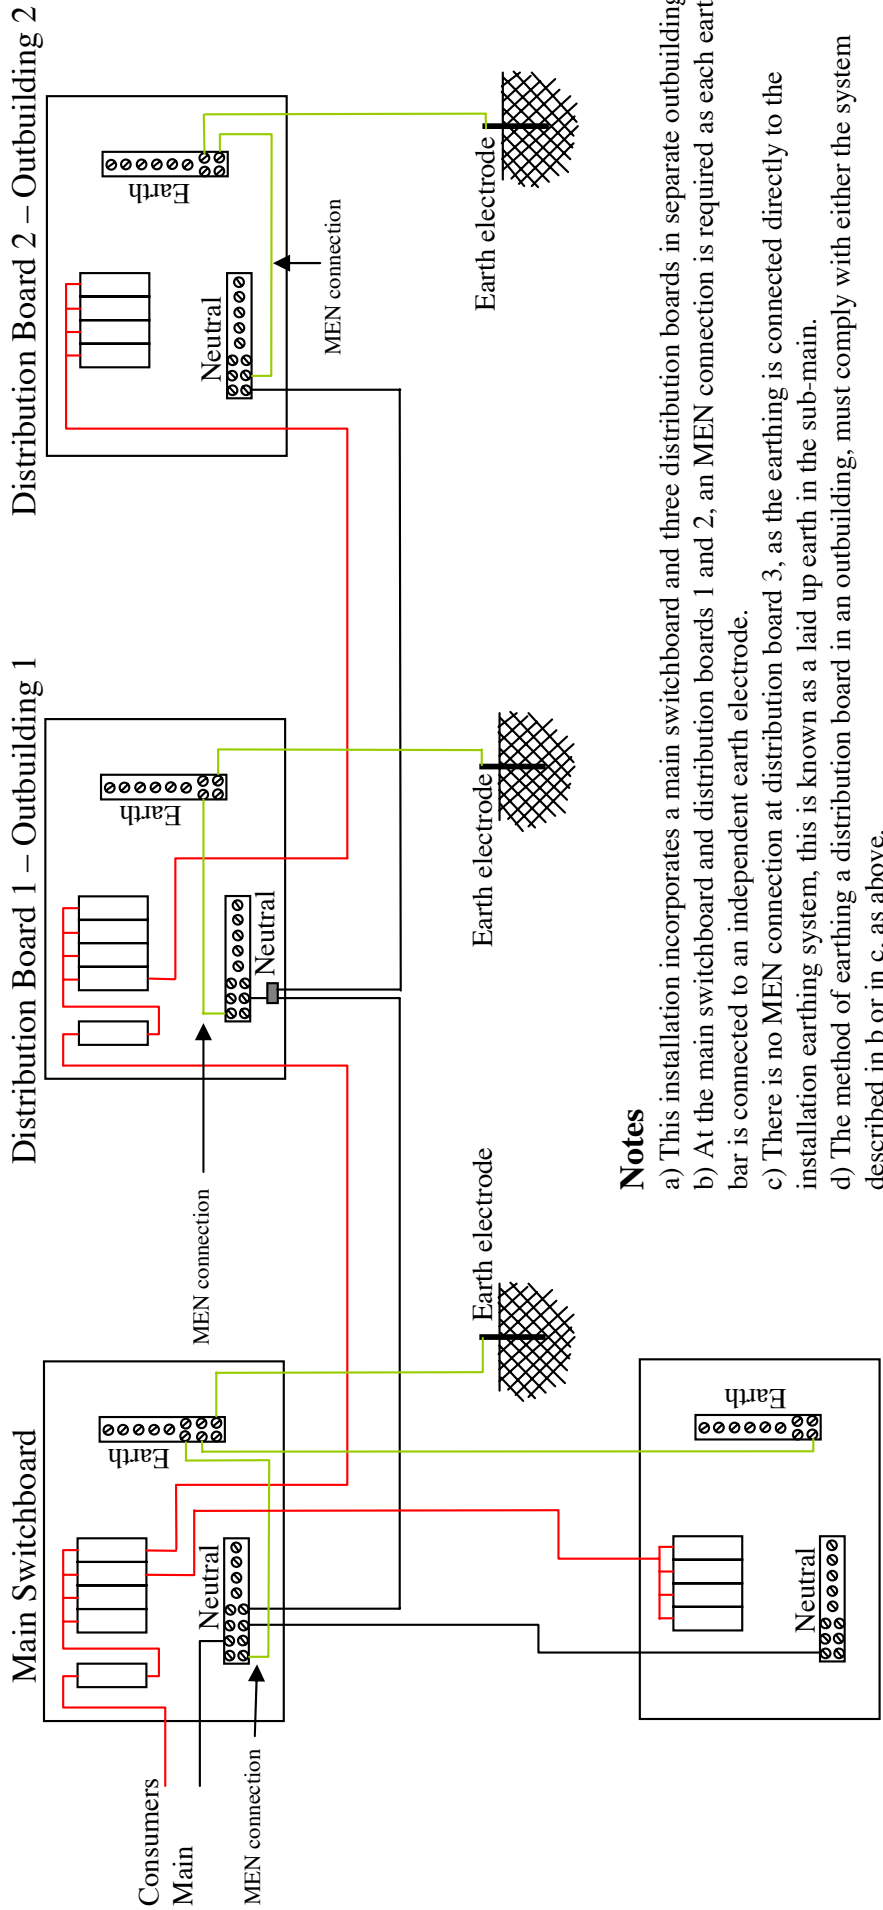
# Multiple Earthed Neutral (MEN) System

- a) This installation incorporates a main switchboard and three distribution boards in separate outbuildings.
- b) At the main switchboard and distribution boards 1 and 2, an MEN connection is required as each earth bar is connected to an independent earth electrode.
- c) There is no MEN connection at distribution board 3, as the earthing is connected directly to the installation earthing system, this is known as a laid up earth in the sub-main.
- d) The method of earthing a distribution board in an outbuilding, must comply with either the system described in b or in c, as above.
- e) The neutral conductor supplying distribution board 2, does not rely on a terminal at the distribution board in outbuilding 1 for its continuity.

- 1.4.62 Definition of the MEN system
- 5.5 Size of Earthing Conductors
- 5.6.3.1 Main Earthing Conductors
- 5.6.6 Earthing in Outbuildings and Detached Portions of an Electrical Installation
