Truck tipping safety

Details of incident

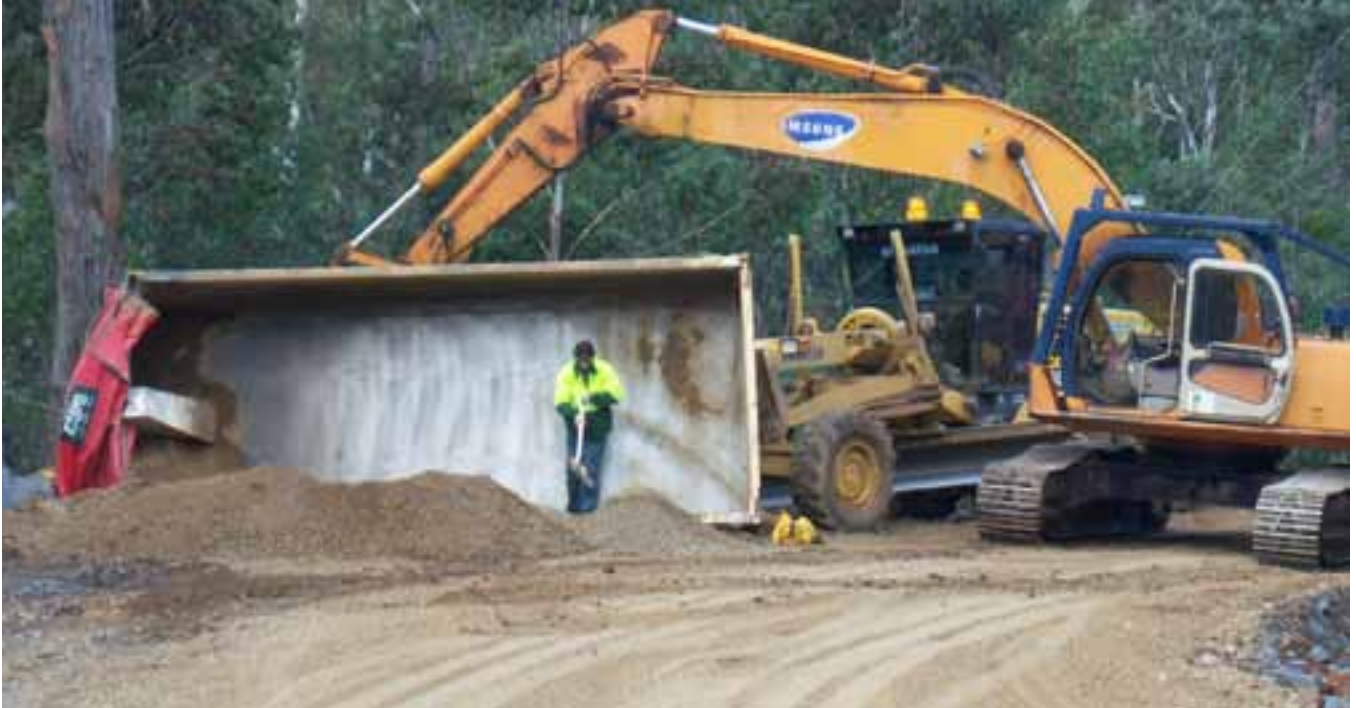
A Superdog tipping trailer, with a 13.8m³ tray and undercarriage combination, rolled over on an unsealed road.

An inspection of the chassis by a structural engineer after the rollover highlighted the damage sustained: a detached hydraulic ram, deformed angle rails and pivot points for the ram, impact marks to the chassis tail plate and structural deformation of the chassis rails. The tray suffered superficial damage to the sides and fixtures.

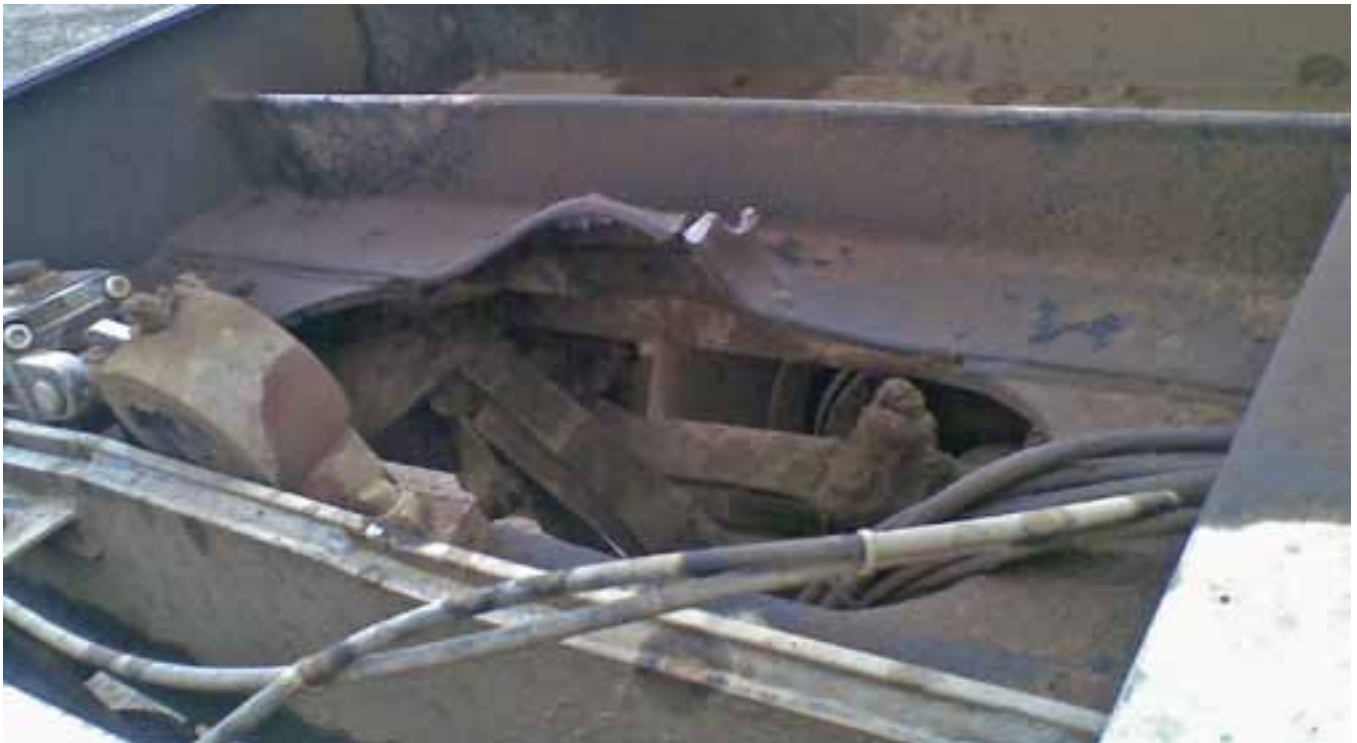
- *maintenance regime*: A structural engineer inspected the company's remaining fleet of tip trucks and dumpsters and found a series of structural cracks under the tray proximate to the ram socket including the supporting angle rails, the welding joints of the tray cleats, cross beams and transverse angle stiffeners. This would suggest insufficient maintenance
- *camber of road and centre of gravity*: The condition of the load combined with the camber of the road can lead to instability. A wet load may slide unevenly from the rear of the tray, therefore shifting the centre of gravity. Camber inclines of 3% have resulted in roll-overs nationally

This photo shows the undercarriage angle rails

- conduct a risk assessment of each tipping job before starting, taking into account the condition of the load, the camber of the road, and the operating parameters of the tip truck or trailer
- from this risk assessment, develop and implement safe work procedures
- develop a maintenance schedule. This must include regular checks of all hydraulic systems (including brakes and hoists), the mounting points for the ram, the rail and beam supports, and all welding joints for structural cracks. Maintenance must be carried out to a standard equal to or better than the manufacturer's specification
- ensure the operator of the vehicle is trained and aware of the safe operating limits of the tray and the hydraulic hoist.
