Electricity Industry Bulletin No: 62 September 2006

FOR THE ATTENTION OF ALL ELECTRICAL WORKERS

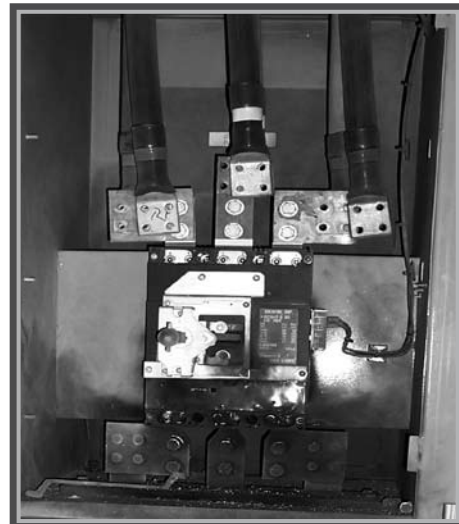
Recently an experienced electrician was seriously injured as a result of a short circuit in a switchboard. The worker was in the process of disconnecting de-energised sub-mains from an 800amp circuit breaker with the line side of the breaker still live. What actually initiated the short on the line side of the breaker is still a mystery at this stage. The damage to the switchboard and injuries sustained were extensive. With the switchboard in close proximity to the substation and mains consisting of three 630mm² cables per phase, the estimated fault level at the point of the short circuit would have been close to 38,000 amps. The resultant explosion caused the worker's jumper and shirt to ignite. The severe burns to his hand and chest required skin grafts. Not to mention the cost of repairs.

Please, Please ensure that in the first instance you isolate all associated and nearby live parts. If there is absolutely no alternative why certain parts cannot be isolated, then take all appropriate precautions to eliminate (not just reduce) potential risks. For further information in this regard refer to AS/NZS 4836 *Safe Working on low-voltage Electrical installations*.

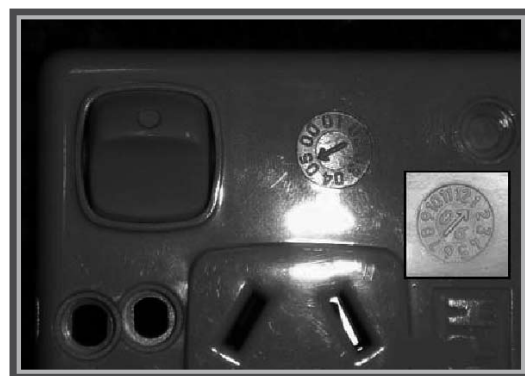
The differences are sufficient enough to identify the look-alike socket outlets as unapproved. There are a number of quality issues associated with the unapproved socket outlets, the most significant being the switch mechanisms breaking down with minimal use. Testing shows this could happen with as little as three switching operations resulting in the dolly on the switch mechanism falling out and exposing live parts.

The main difference that is most distinguishable is that the word "Made" is missing from the sentence "Made in Australia" located below the cable terminal tunnels.

Electricity Standards *and* Safety advises electrical contractors and electricians to be cautious if offered HPM socket outlets from a person who is not your normal supplier.
