Safety Alert

Nº.6 1998

ASBESTOS EXPOSED IN PLAYGROUND TRAIN

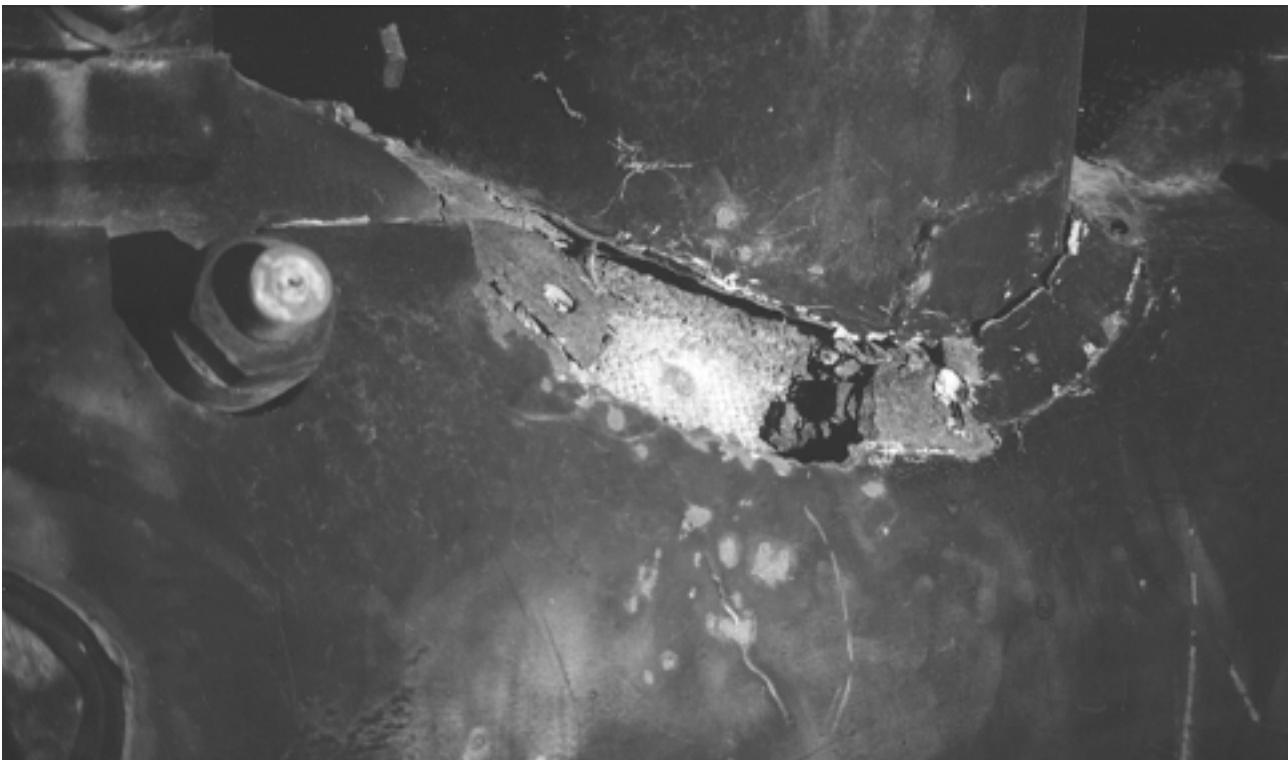
The recent discovery of exposed asbestos at a children's playground in Hobart has highlighted the importance of regular inspection and maintenance of any equipment containing asbestos. The asbestos, in an old train boiler and engine in the playground, was exposed by several rust holes.

The exposed asbestos insulation in the train could have posed a significant risk to anyone disturbing it. In this instance, the council concerned was contacted and took prompt action to repair the holes.

Train boiler showing rust holes and exposed asbestos insulation

- Owners of trains and traction engines including those that the public has access to and that are not known to be free of asbestos, must regularly inspect and maintain their equipment.
- The inspection and maintenance activities must be recorded in a hazard management register.
- Hazard management registers must be kept in accordance with WorkSafe Australia's *Asbestos Code of Practice*. This publication is available from Commonwealth bookshops.
