Safety Alert
N°10 1997

SIGNIFICANT INCIDENT REPORT

SURFACE DRILL RIGS PROTECTION FROM ROTATING PARTS

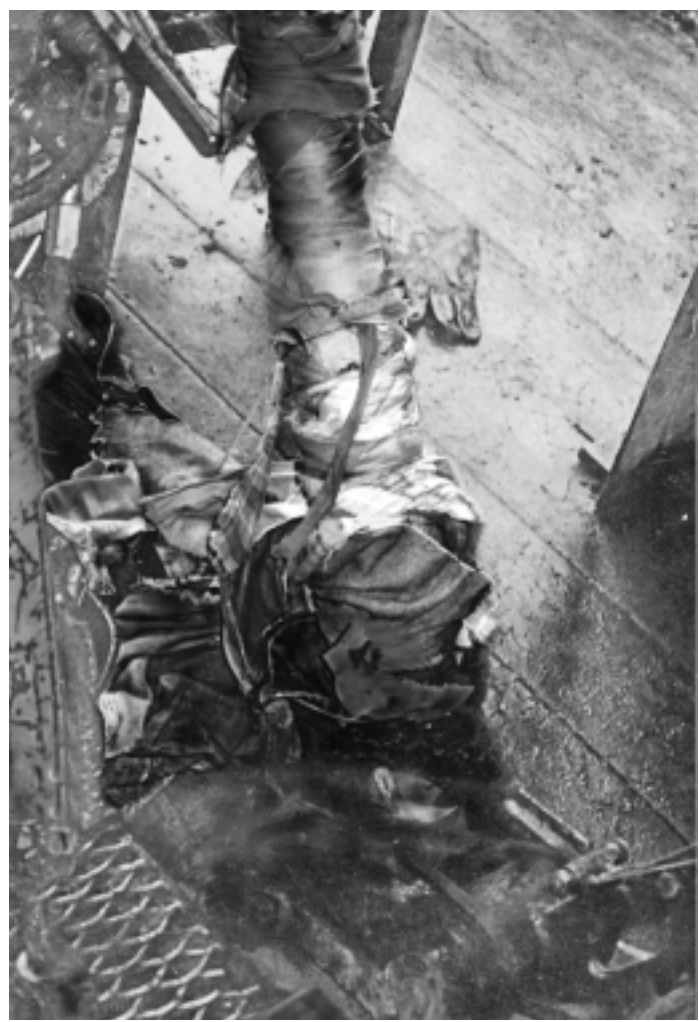
A worker on an exploration drill site was seriously injured when his clothing became entangled in a rotating drill rod. The man had attempted to pick up some tools from the floor beneath the drill head when his clothes became caught in the rotating rod.

- No guarding for the rotating drill rods.
- Carrying out other repairs in close proximity to the rotating drill rods.
- Cramped working conditions.

The worker's clothes wrapped around the drill rod

- suitable guarding be developed for all rotating parts on drill rigs (Refer to Australian Standard AS4024.1 – 1996, *Safeguarding of Machinery*).
- procedures be put in place to remove operators from areas near the rig where they are likely to become caught by rotating parts.
- all other work that is not related directly to drilling be performed remote from the drill.
- attention is also drawn to the duty of care of employers, employees, manufacturers and suppliers under the *Workplace Health and Safety Act 1995*.
