Number 1 2007

Shipping container door comes unhinged

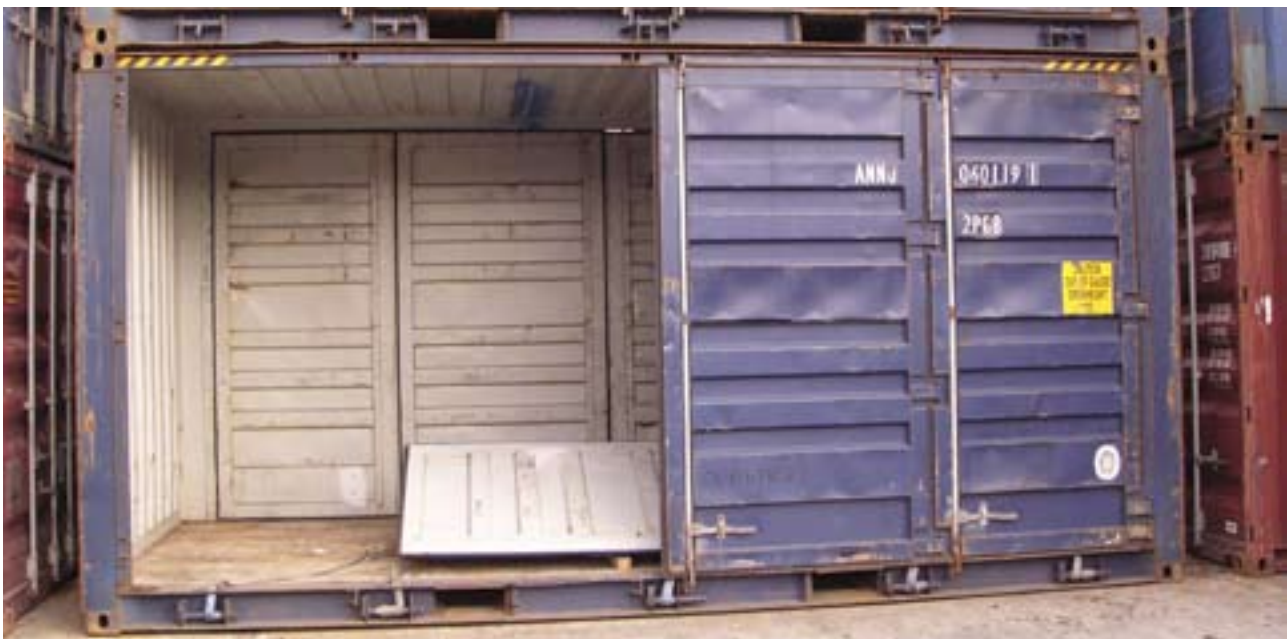
An examination of the container revealed the retaining lugs – welded to the container frame and in which the hinge pins are fixed – exhibited severe corrosion.

Photograph 1 shows the container with the door inside the container. The hinge pin lugs are visible on the container frame.

In order to prevent possible injury of a person by a door falling on them, all containers of this type should be inspected for corrosion of hinge lugs.

Where corrosion is identified, and the integrity of the hinges is in doubt, the container should be withdrawn from service, inspected by a competent person, and repaired in accordance with the appropriate standards.

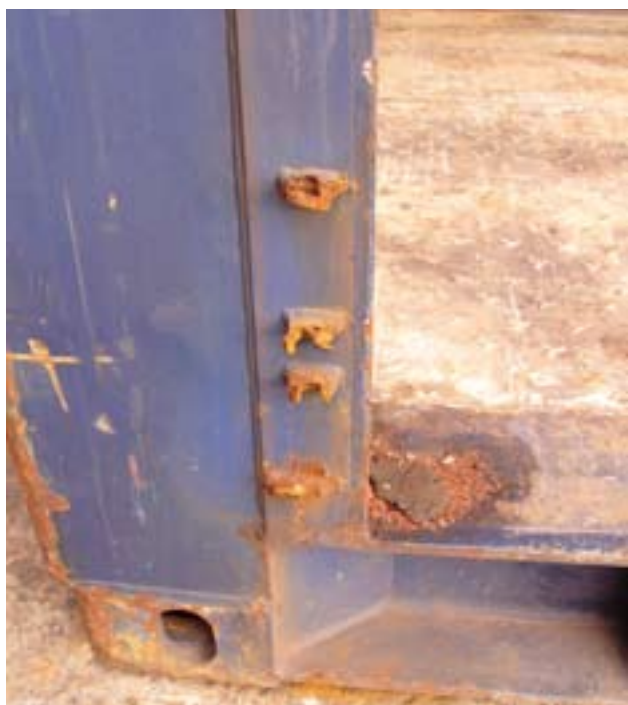
Photograph 2 shows the lugs on the side of the container. Note the fourth lug [lowest] is completely missing.

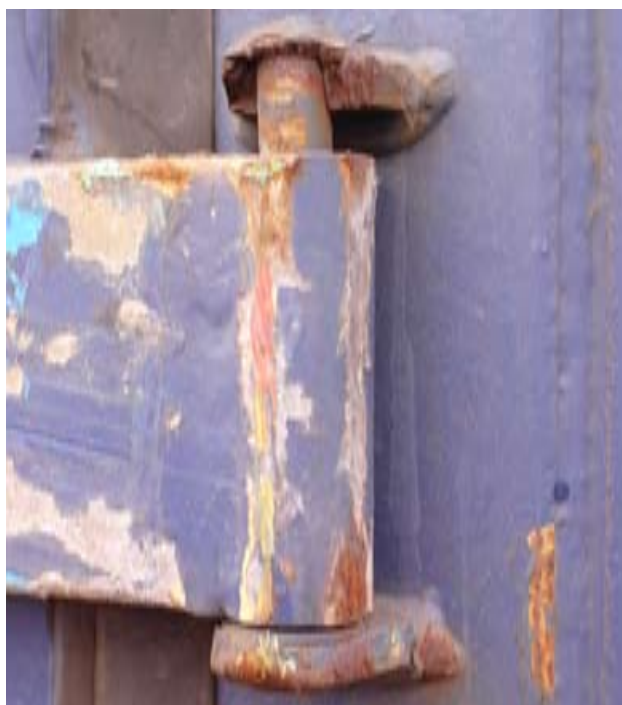
Photograph 3 shows a hinge pin in a severely corroded hinge lug.

Shipping containers are exposed to environments, during transport and storage, which promote the corrosion of metal parts, particularly where applied paint coatings have sustained damage.
