## Operator sustains serious injury in fall from bulldozer

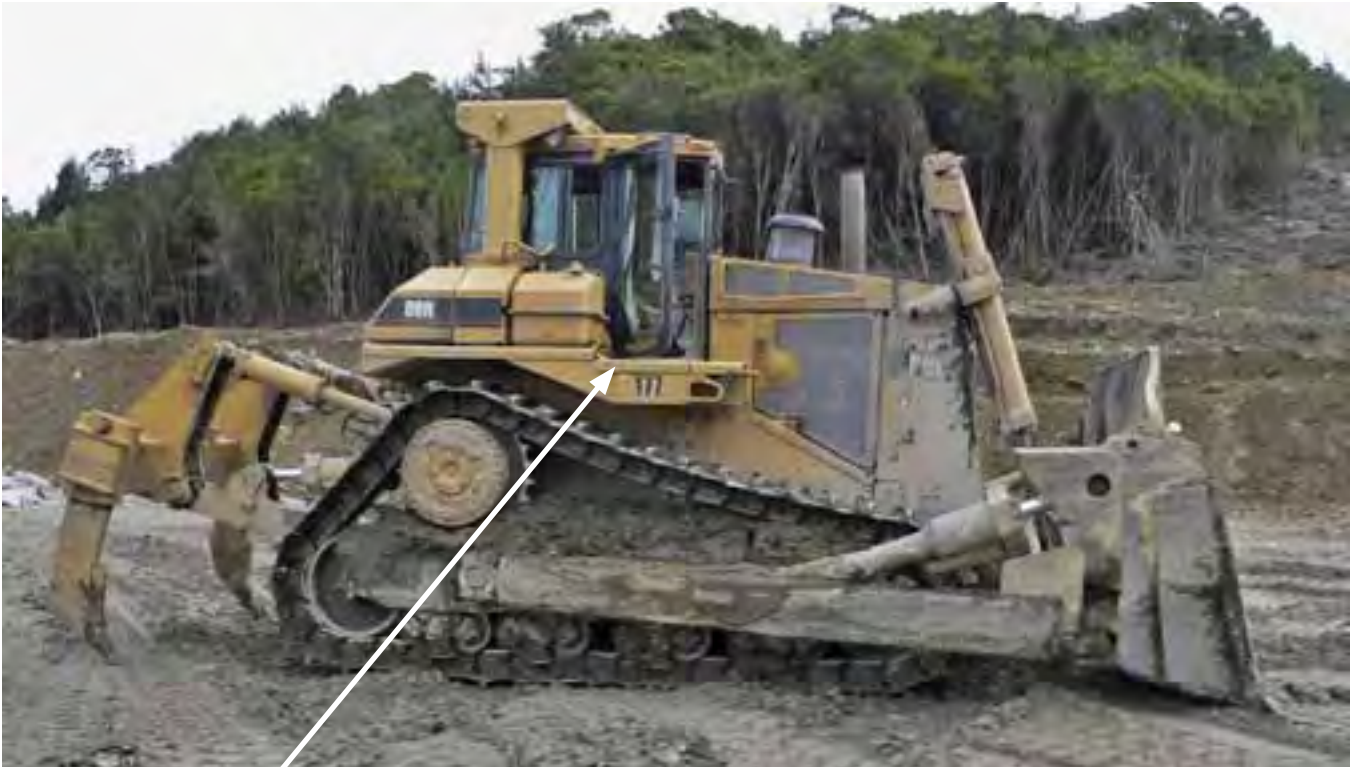
*Arrow indicates the platform the operator fell from*

A bulldozer operator climbed out of the cab of a D9 bulldozer to stretch his legs. While he was standing on the platform, he slipped and fell forward onto the frame of the dozer. He fractured his femur (thigh bone) and required hospitalisation and surgery.

An investigation into the incident found that the bulldozer platform, steps and handgrips were in good order and the environmental conditions were normal. The operator apparently became distracted by watching a truck tipping on the pad and lost his footing.

- Remember the risks of falling from large mobile machinery.
- Climb down onto the ground to stretch, rather than stretching up on the platform.
- Remember to use three points of contact when climbing on and off mobile machinery.
