Number 5 2003

Tractor Operating Control: The Forward-Neutral-Reverse Shuttle Lever

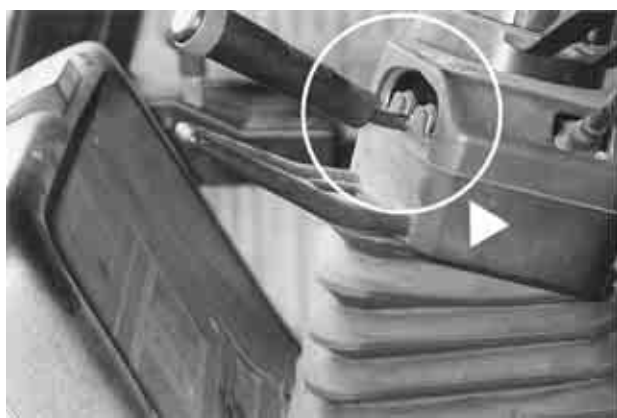
Here the lever is in the notched neutral position.

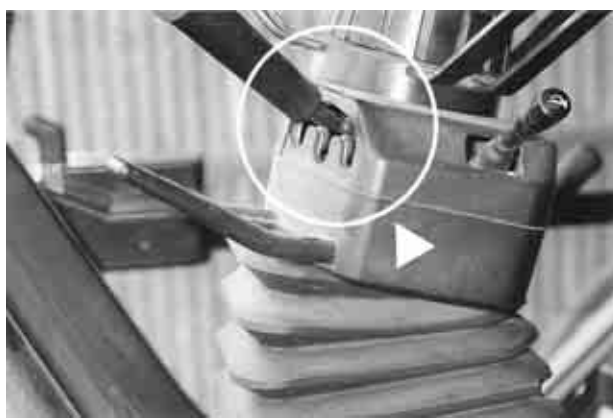
Here the control lever has remained balanced on top of one of the high point bearings between the notches.

- Under certain circumstances, the control lever can remain balanced on top of one of the high point bearings between the notches.
- If the lever is accidentally left in this position, it only takes a small bump against the steering wheel (or even just closing the cab door) to allow the lever to drop down into one of the adjoining notches. This would then immediately engage the drive of the tractor.

If this were to happen while a driver is disembarking from the tractor, he may be severely injured by the suddenly moving tractor.

- That the lever mechanism and roller bearings are in good working order and well lubricated
- That the return spring is in good working order, as per the manufacturer's specifications.
- That all tractor operators are advised of this potential problem.
- That all tractor operators always check that the lever is actually positioned in the neutral notch before embarking from the tractor.
