## Vehicle loading crane safety

Recently a person was fatally injured as a result of being crushed by the boom of a vehicle loading crane. The crane was mounted on a vessel.

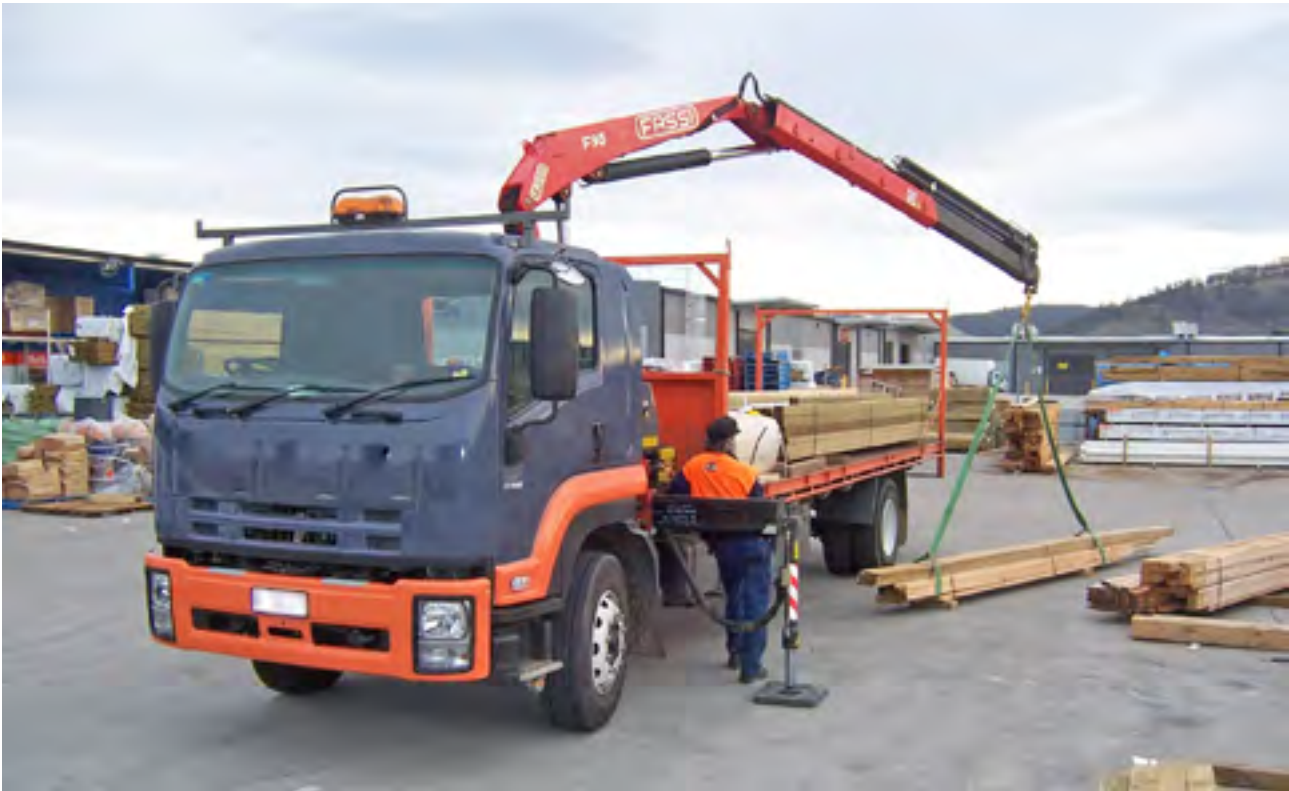
- inappropriate positioning of the operator, which can lead to injury as a result of crushing between the crane and the support vehicle
- inappropriate positioning of operator's assistants, which can lead to inadvertent contact with the crane boom and the supported load
- inadequate assessment of surroundings, which can result in contact or entanglement of the crane with powerlines, plant and people.

- Operators must ensure they and their assistants are positioned so they won't come into contact with the crane or its load, even if there is unintentional movement. They should also have safe escape routes established.
- Operators must follow manufacturer's instructions at all times.
- Operators must review the site before entry to ensure adequate clearances to power lines and structures, during the entry and exit of the vehicle and during unloading operations.
- Operators should be appropriately trained before they are allowed to operate any vehicle loading crane.
- Where a crane has a capacity a greater than 10 metre tonnes (that is, they can lift 1 tonne at 10 metres, or 10 tonne at 1 metre), operators must hold the appropriate license to perform high risk work.
