Safety Alert
N°2 1999

Fork Lift Crushes Worker

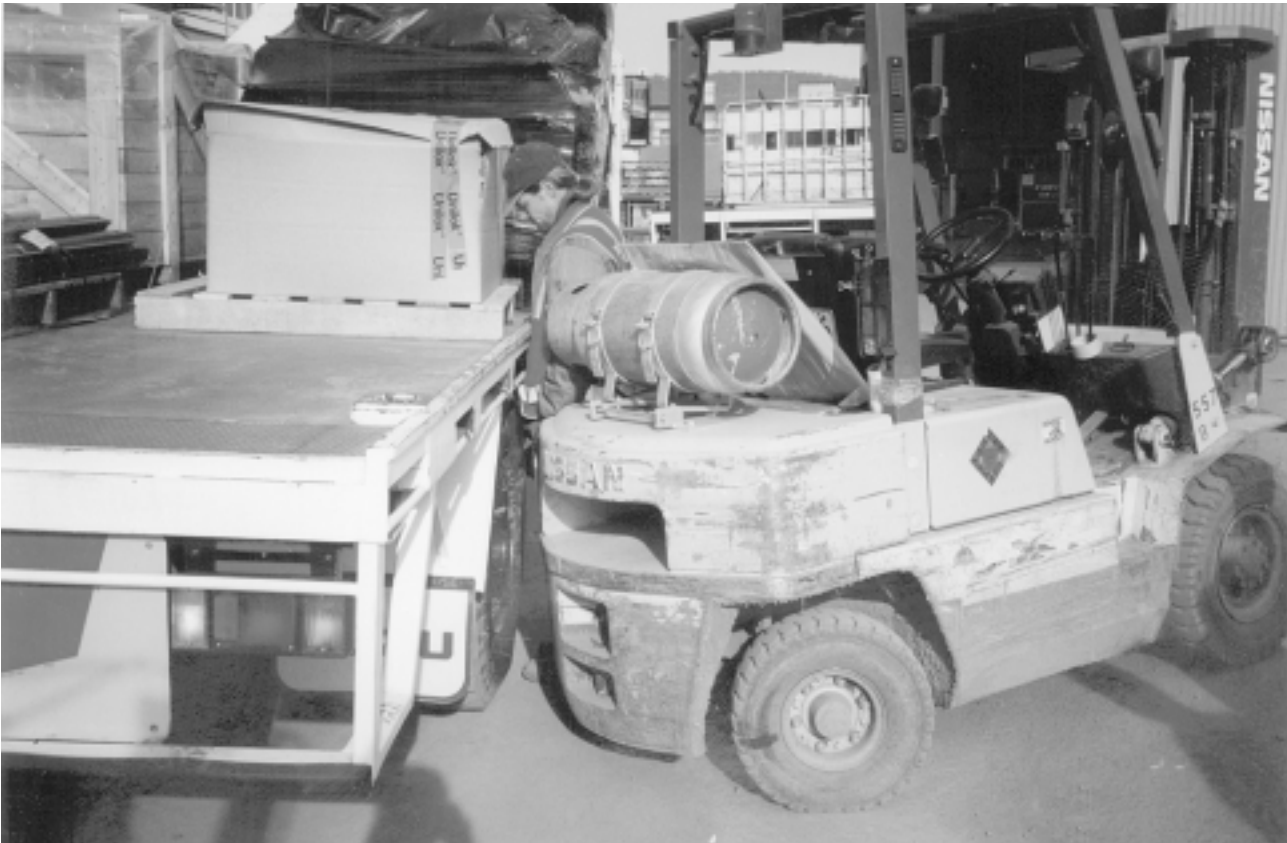
A forklift was being used to load a truck with pallets of general goods. During the loading, the truck driver noticed that some goods should not have been on the truck. He summonsed the forklift driver over to double check.

The forklift driver stopped the forklift, left the motor running and got off the vehicle.

Both men were standing beside the truck tray looking at the pallet when the forklift rolled into them and wedged them both between the forklift counterweight and the truck tray. The forklift operator managed to free himself and consequently moved the forklift freeing the truck driver.

The truck driver suffered injuries to his pelvis and legs.

- The forklift driver apparently failed to apply the handbrake and assumed that the forklift would not roll because the ground was reasonably flat.

- Never leave any vehicle unattended without applying a handbrake, and when appropriate, turn the motor off and place the vehicle in gear.
- Ensure the forks of forklifts are lowered to the ground.
- If possible, park a forklift in a designated area where it can be stopped from rolling by a rigid barrier.
