Safety Alert

N°3 2002

Safety Attachments on Pneumatic Secateurs

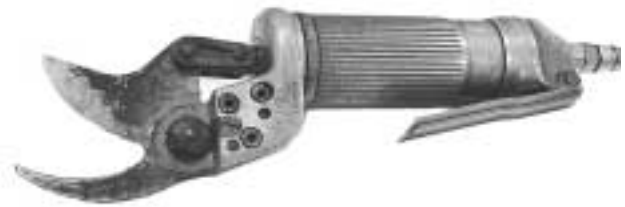
**OLD**

In a recent incident, an employee at an apple orchard had the end of his ring finger amputated by pneumatically operated secateurs (pictured above right).

The worker was descending a ladder when his foot slipped. In an attempt to stop his fall, the worker grabbed the top rung of the ladder. He was still holding a pair of secateurs. During this action, the unguarded trigger of the secateurs was activated and the amputation occurred.

- the secateurs were manufactured in 1978
- the secateurs had no safety features; no active trigger guard or hand-operated safety catch.

- That employer and employees must ensure plant is safe to use and contemporary safety standards are adopted as required.
- That a hazard identification and risk assessment is carried out on all plant and processes involving plant in the workplace as per legal obligations.
- That employees and contractors are trained in the safe use of plant, and appropriately supervised.
