Safety Alert

Nº.4 1999

Woman Scalped in Go-Karting Accident

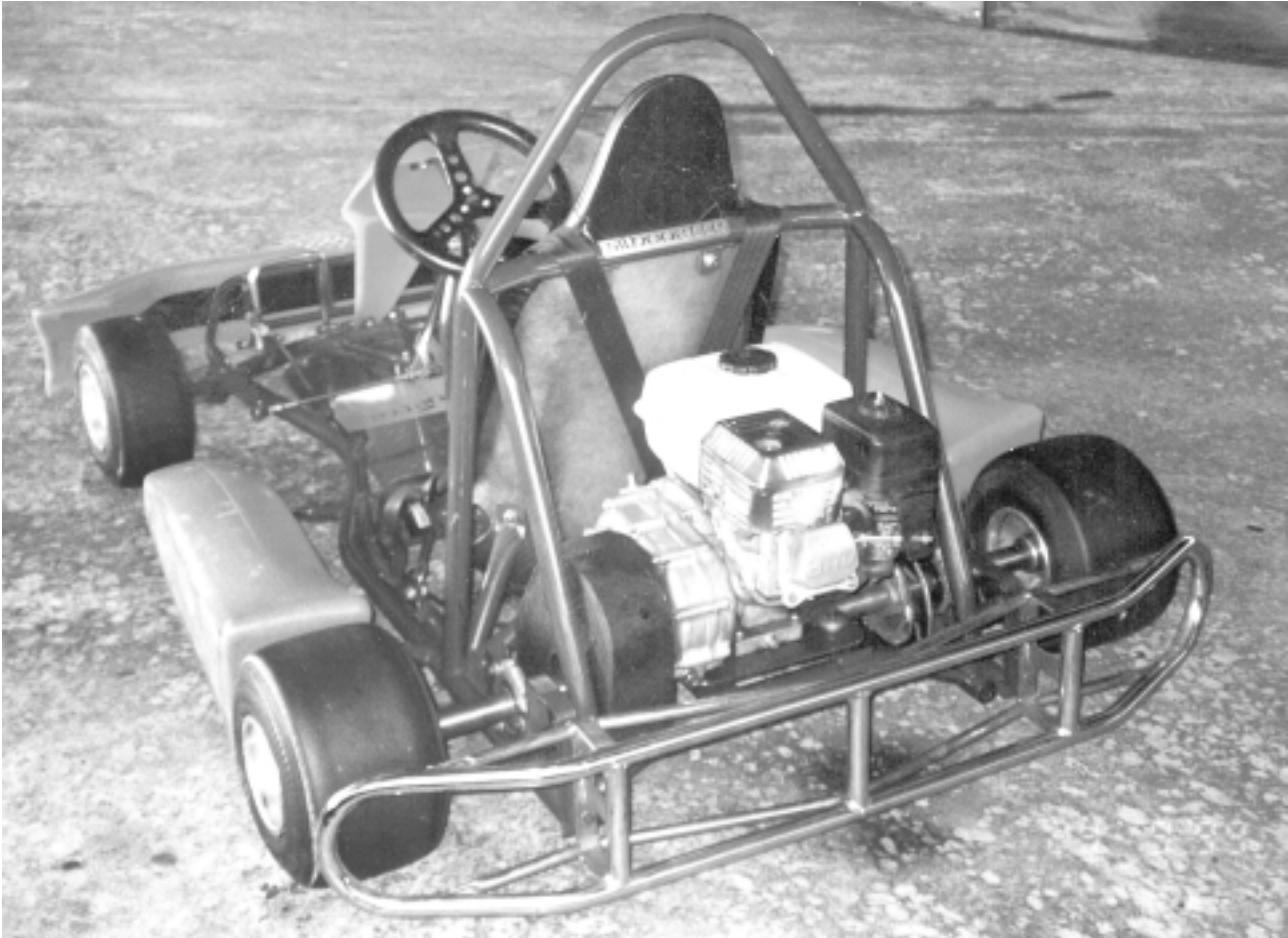
A 20-year-old Gold Coast woman underwent microsurgery after being scalped when her hair became entangled in the axle of a go-kart she was driving. Large tufts of hair and sections of the woman's scalp were ripped from her head in the accident. She was taken to hospital and was in a satisfactory condition after undergoing microsurgery.

- An investigation into this accident revealed that:
- The woman had long hair which was not restrained by suitable headwear.

- Go-karts should have guards fitted over rotating components.
- Long hair and loose clothing should be restrained.
- Drivers should be supervised so that potential risks are identified before an accident occurs.
- Go-kart designers, manufacturers, suppliers and operators should ensure that go-karts are fitted with appropriate guards.
- Designers, manufacturers, suppliers and operators are required by law to ensure the safety of everyone in the workplace. Go-kart operators are also required to maintain go-karts in a safe condition.
- Employers and go-kart owners should be familiar with, and apply Australian Standard 3533.2 – *Amusement Rides and Devices Operation and Maintenance*
